## PHOTOGRAPHIC OBSERVATIONS & SOME PROPOSED SOLUTIONS

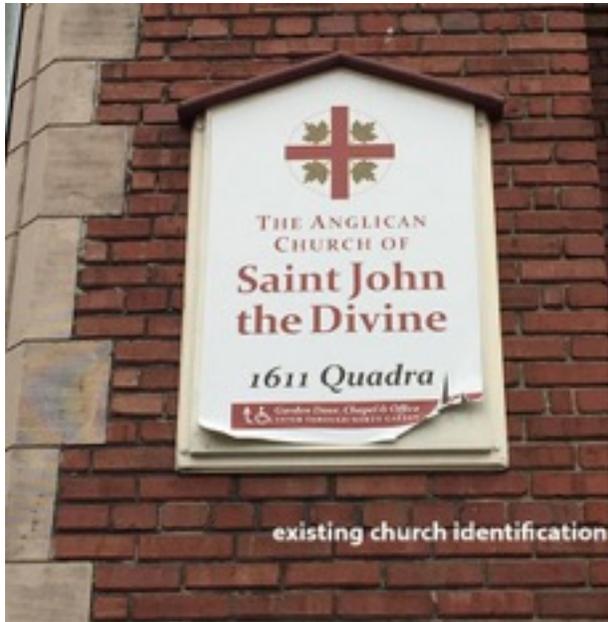
existing church identification and notices on Quadra Street

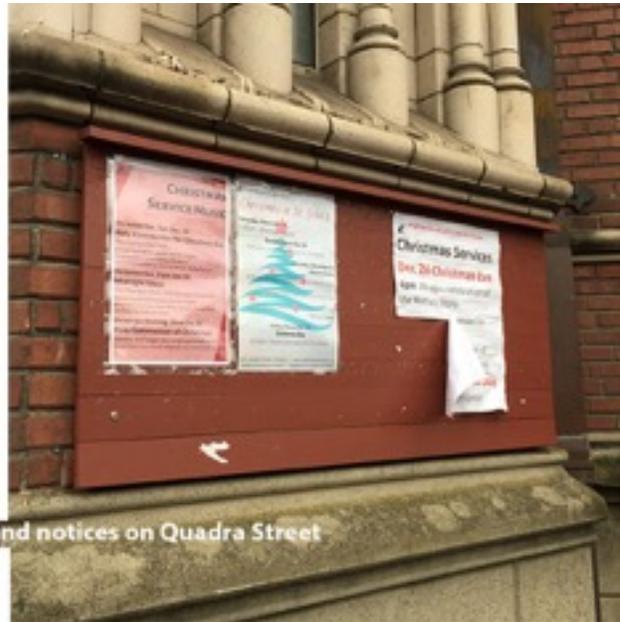
Poor state of signage on exterior of church.

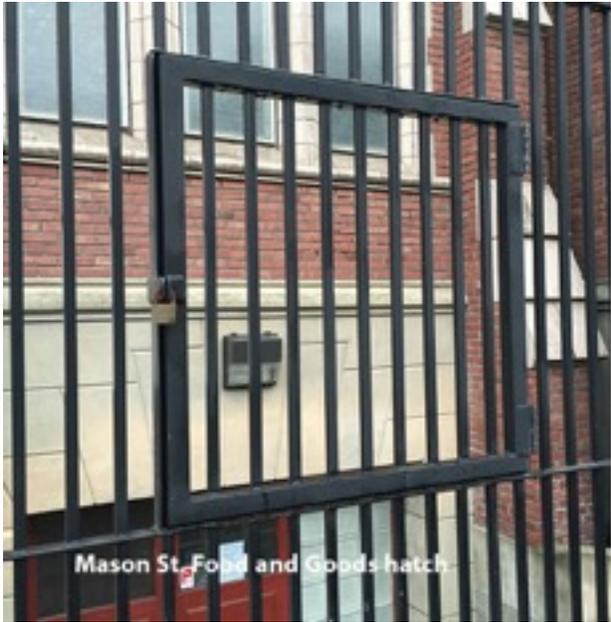
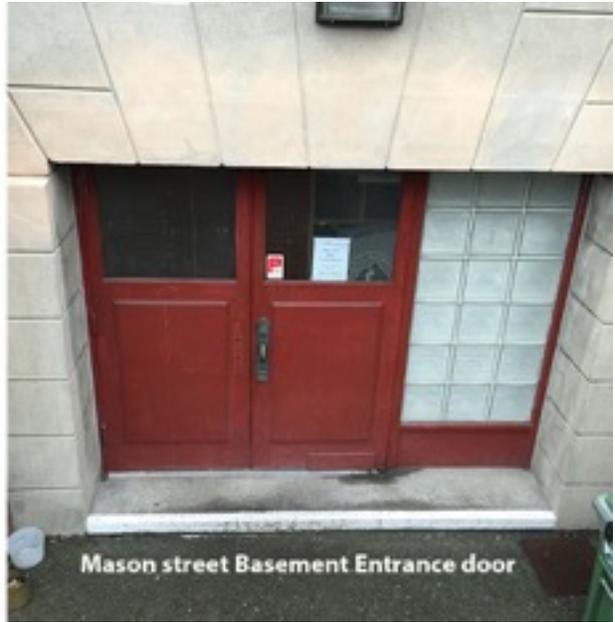
Existing freight delivery hatch to basement.

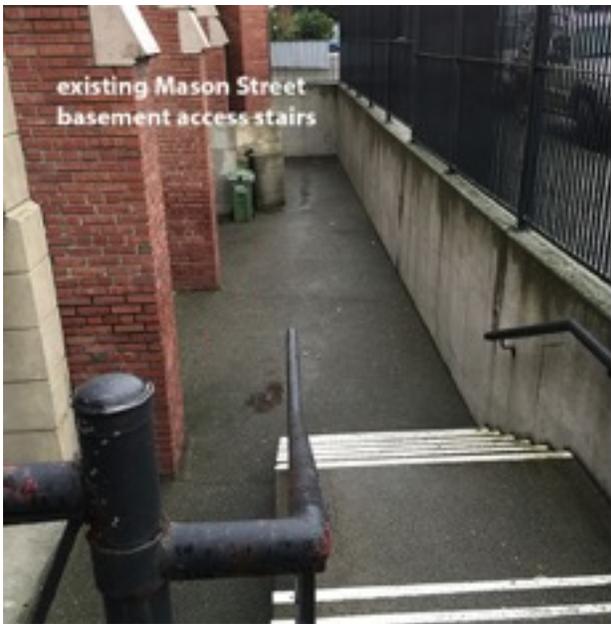
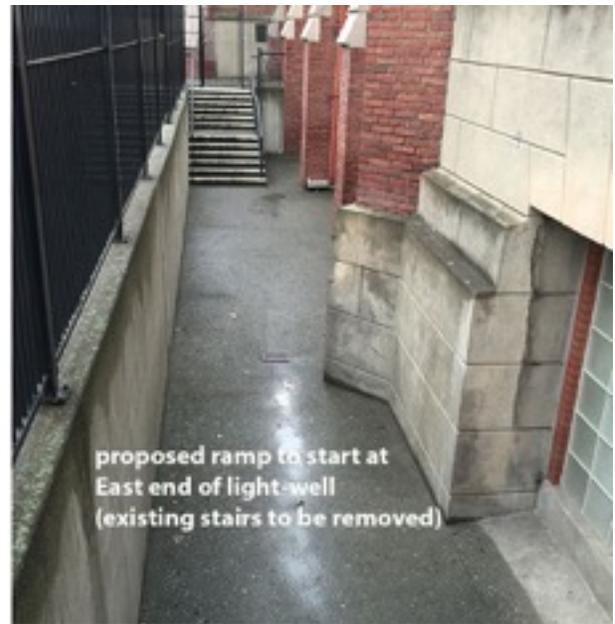
Mason Street light-well - entry to basement.

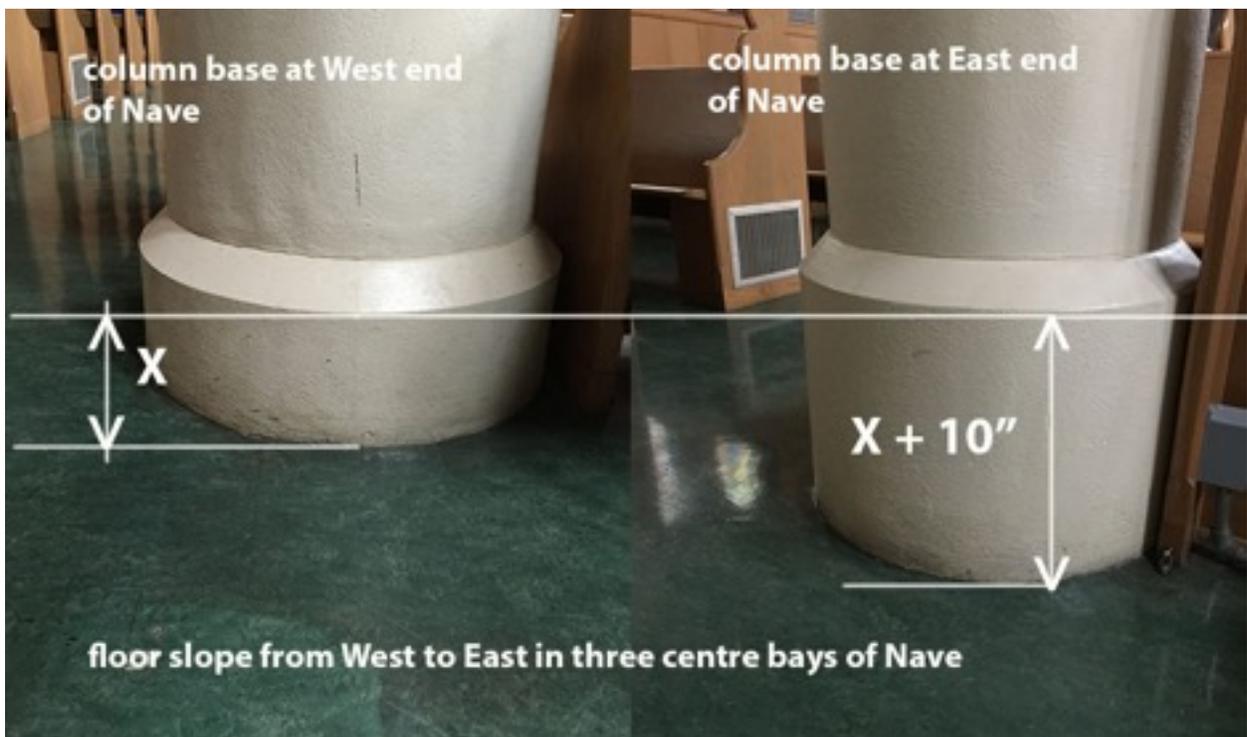
Evidence of the slope of the floor of the nave.

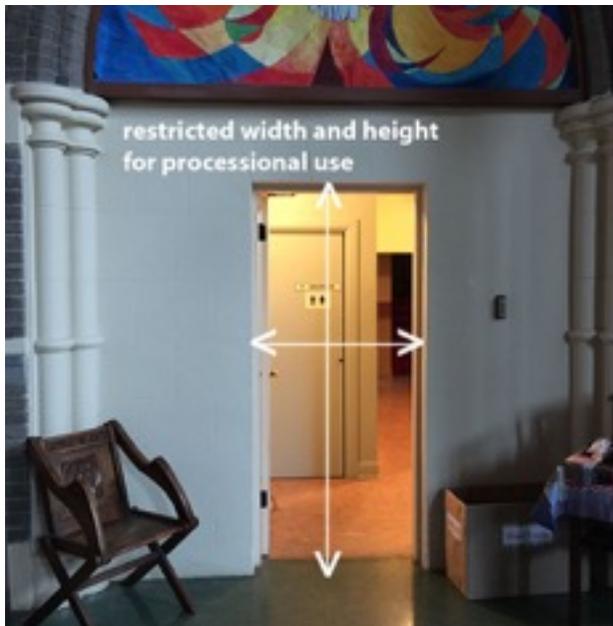
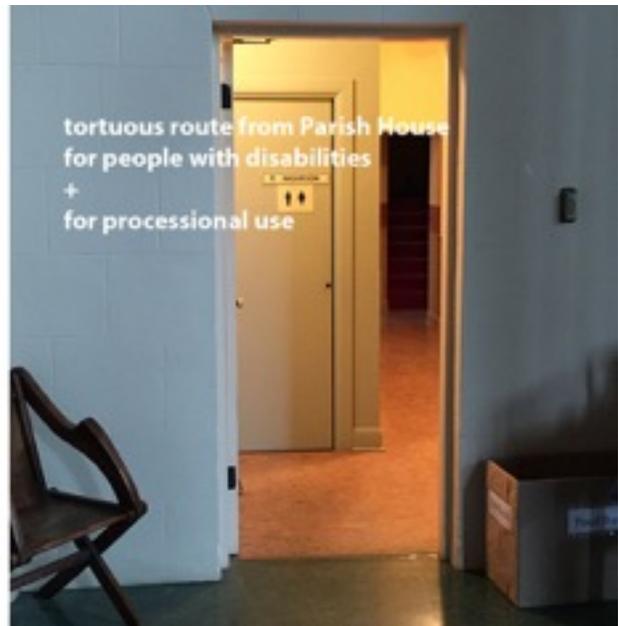
Observation of the restricted space of the corridor from the Church to the Parish House.
